Technical Bulletin

Unitized Wheel-End Assembly Inspection with a Dial Indicator Replacement Hub Inspection Spindle and O-Ring Installation Hubcap Installation All Meritor Front Non-Drive Steer Axles with Unitized Wheel Ends

TP-0251
Revised 10-24-02
10678/24240

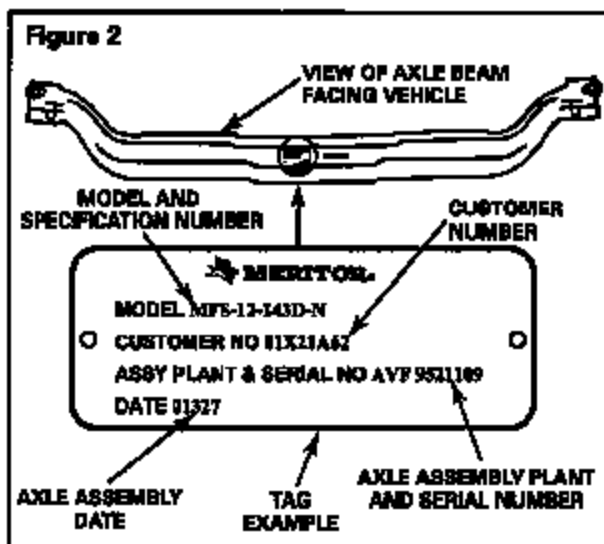
If the hubcaps are missing, you can use the axle model number to determine if the axle is equipped with unitized wheel ends. To identify the model number, refer to the axle identification plate on the front of the beam. Figure 2.

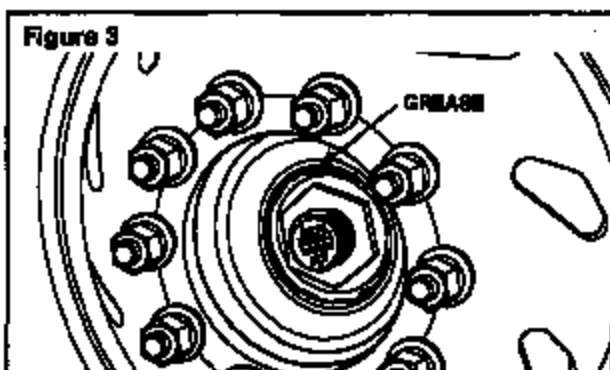
NOTE: The outboard and inboard seals may purge small amounts of grease that are visible during inspection. Figure 3. This is a normal occurrence.

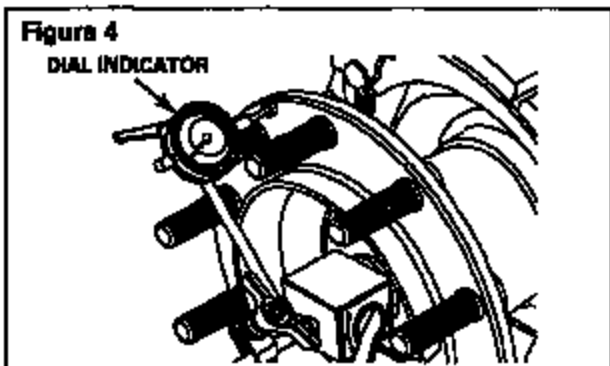
4. Remove the wheel and drum. Attach the magnetic base of a dial indicator to the end of the spindle. Figure 4. Touch the indicator stem perpendicular against the unitized wheel-end's mounting face.

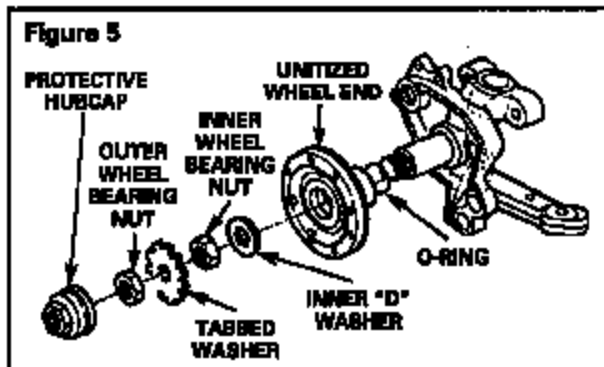
6. Push the unitized wheel end straight IN. Note the reading. Pull the unitized wheel end straight OUT. Note the reading.
 - If the total movement of the dial indicator is less than 0.003-inch (0.08 mm): Inspection is complete. No adjustment is required.
 - If the total movement of the dial indicator is 0.003-inch (0.08 mm) or greater: Remove the OUTER wheel bearing nut and tabbed washer. Tighten the INNER wheel bearing nut to 600-700 lb-ft (879-949 N·m) while rotating the unitized wheel end a minimum of five rotations. Figure 5. ①

7. Install the **INNER "D" washer** and the **INNER wheel bearing nut**. Tighten the **INNER wheel bearing nut** to 500-700 lb-ft (679-949 N·m) while rotating the unitized wheel end a minimum of five rotations. **Figure 5.**

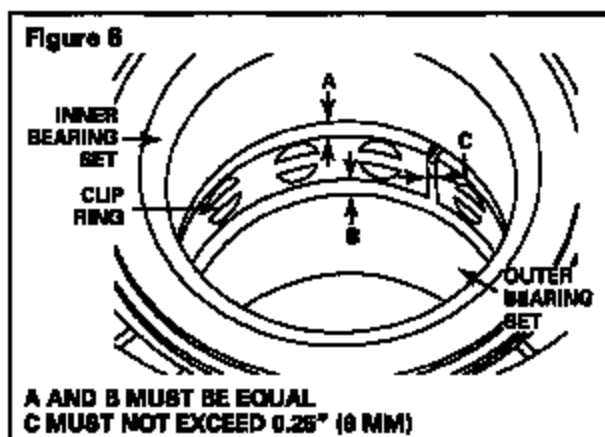
1. Remove the replacement hub from the box and place it on a clean surface.
2. Examine the interior of the hub to verify the following.
 - A. The inner clip ring has not become dislodged in shipment and is in correct alignment with the inner and outer bearings. The gap between the inner and outer bearing sets and the clip ring must be equal. Figure 6.
 - B. The gap between the ends of the clip ring must be equal and not exceed 0.25-inch (6 mm). If necessary, adjust by hand. Figure 6.
 - C. The bearing face must be clean with no seal coating, dirt or dust.

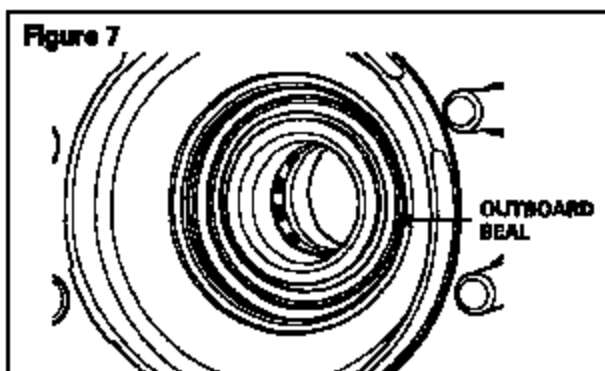
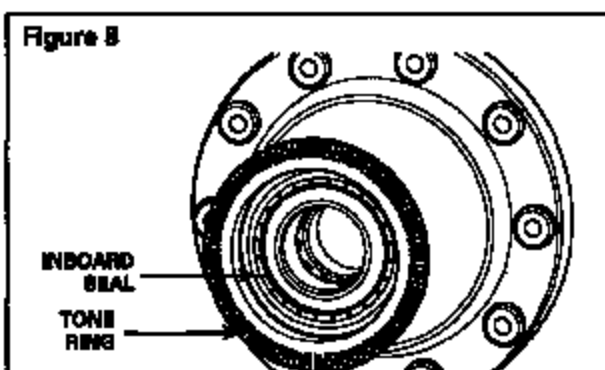
3. Examine the exterior of the hub to verify the following.
 - A. There is no visible damage to the inboard or outboard seals and the bearings have not become unseated. Figures 7 and 8.
 - B. The tone ring teeth are not damaged and there are no broken or missing teeth on the tone ring. Figure 8.

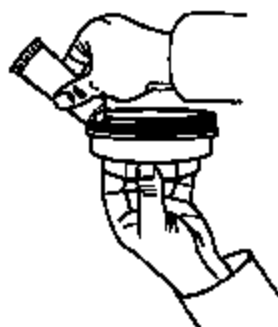
Figure 9

2. Apply a continuous 1/8-3/16-inch (3-5 mm) bead of RTV sealant to the outside first thread around the entire circumference of the hubcap. You must use Meritor part number 2297-Z-7098 RTV sealant, Loctite® Adhesive Sealant number 5699. **Figure 9.**
